Manhole Inspection Summary

Manhole # S43GG_053MH

Insp Date: **6/9/09 3:02 PM**

Location Address: **1634 PRESTON ST (REAR) ON ELLSWORTH ST**

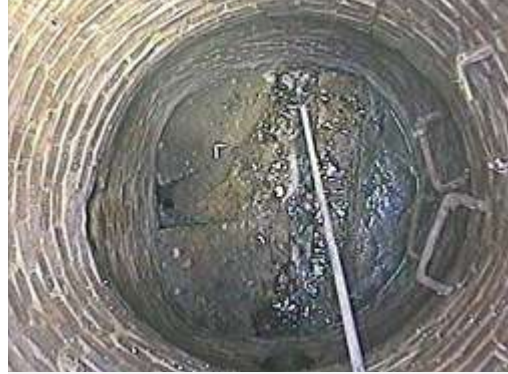
Top View

Comments **MAJOR DEBRIS IN CHANNEL.**

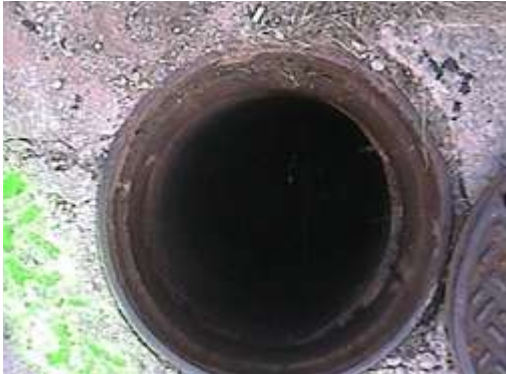
Defect 3

Steps Count: **8** Missing: **4** ☒ **Corroded**

corroded steps

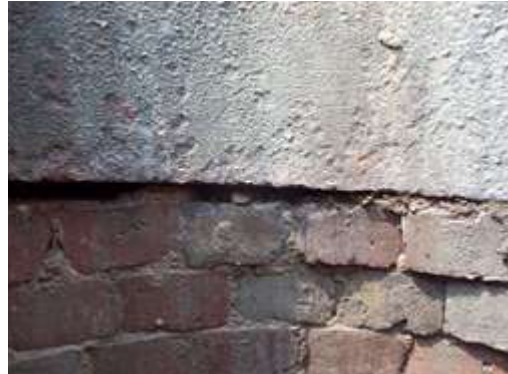
Defect 2

Frame Offset: **1** (in.) Condition: ☒ Sound ☐ Cracked ☐ Leaks

frame offset

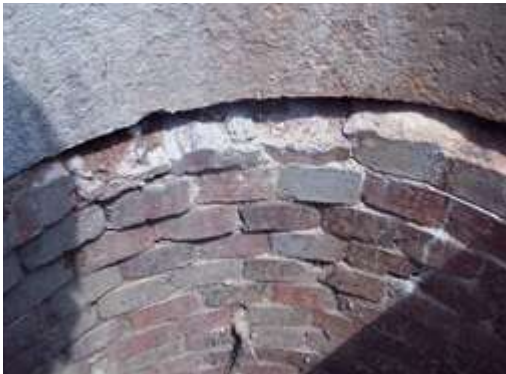
Defect 1

Infiltration: ☐ None ☒ **Joint** ☐ Cracks ☐ Mortar ☐ Roots ☐ Wall

Condition: ☐ Sound ☒ **Cracked** ☐ Root Intrusion ☐ Loose Brick ☐ Deteriorated

Infiltration, corbel cracked

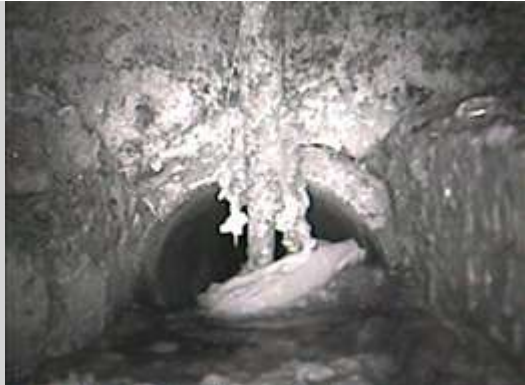
12 O'Clock Outflow

8 in. Circular Gravity Sewer
Pipe Out @ 12 O'Clock

Pipe Height: (in.) Direct
Pipe Material: **Clay** ☐ Pipe Lined
Invert Depth: **12.66** (ft.) Flow Characteristics: **Slow**
Deposits: ☐ None ☐ Mud ☐ Sludge ☒ **Debris** ☐ Grease
Silt Depth: **0** (in.) Deposits Extent: **Heavy**
Infiltration: **None** Pipe Seal Cond: **Sound**

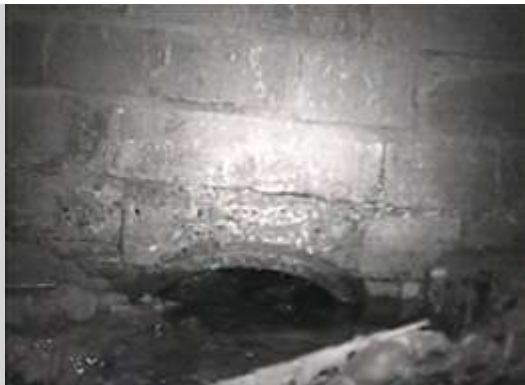
6 O'Clock Inflow

8 in. Circular Gravity Sewer
Pipe In @ 6 O'Clock

Pipe Height: (in.) Direct
Pipe Material: **Clay** ☐ Pipe Lined
Invert Depth: **12.36** (ft.) Flow Characteristics: **Slow**
Deposits: ☐ None ☐ Mud ☐ Sludge ☒ **Debris** ☐ Grease
Silt Depth: **0** (in.) Deposits Extent: **Heavy**
Infiltration: **None** Pipe Seal Cond: **Sound**

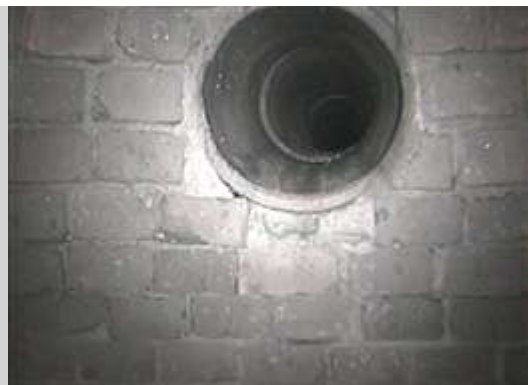
9 O'Clock Inflow

Pipe In @ 9 O'Clock

Deposits: ☐ None ☐ Mud ☐ Sludge ☒ **Debris** ☐ Grease

Silt Depth: **8** (in.) Deposits Extent: **Heavy**

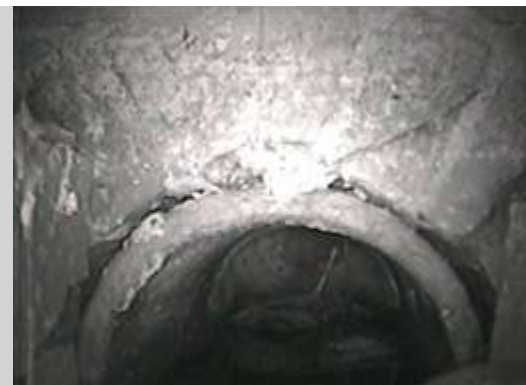
Drop In @ 9 O'Clock

Drop: **Outside** **Direct**

Drop Condition: **Open**
